Ultrasonic Backscatter Technique for Corrosion Detection in Solid Rocket Motors

15 October 1994

J. R. LHOTA, G. C. PANOS, and E. C. JOHNSON Mechanics and Materials Technology Center Technology Operations

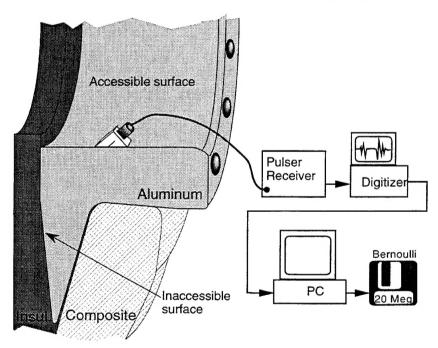
Figure 3. A schematic showing a cross-section of the interface and the inspection hardware set-up.

flight hardware, which had aged beyond the original qualification period, after corrosion was found in sectioned hardware from an aged, scrapped motor case. The backscatter ultrasonic inspection for corrosion was implemented as a part of the requalification process. The region of interest in the inspection was the from the aluminum-insulator interface for the first 1.8 in. from the inner diameter for the entire 360° . A standard scan recorded the signal at seven positions along the 1.8 in. for every degree, i.e., a 7×360 grid. The rf signals were digitally recorded and post-processed for analysis.

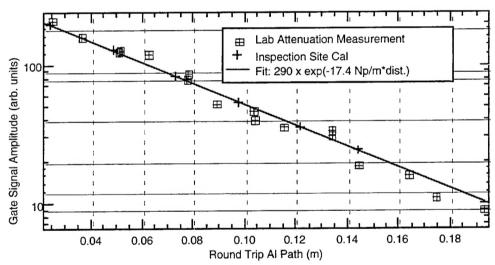
The hardware geometry required scanning the transducer on the inner surface of the boss; a surface that is perpendicular to the aluminum-insulator interface. The signal path varies as the transducer is scanned at a given degree. A sliding gate and Distance Amplitude Correction (DAC) were used to process the data. The attenuation constant for the DAC was taken from pre-recorded data measured on a laboratory sample of similar material and from measurements on a calibration standard at the time of inspection. Both sets of data, plotted in Figure 4, are in good agreement. The value of 17.4 Np/m was used for the DAC.

Figure 4. The attenuation constant of 17.4 Np/m used for DAC was extracted from lab measurements and calibration data.

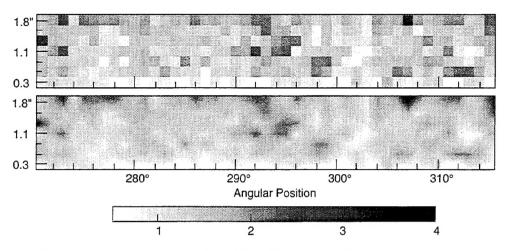
An example of a C-scan plot of the processed data is shown in Figure 5. In the upper C-scan, the data is plotted one pixel for each data point. The lower C-scan is a plot of the same data interpolated to a finer grid to aid in visualizing patterns. The data was normalized such that a value of 4 corresponded to a reportable indication level. No reportable indications were found in this piece of hardware.

Figure 5. Example of C-scan plots of the ultrasonic data after gating, peak detection, DAC and normalization.

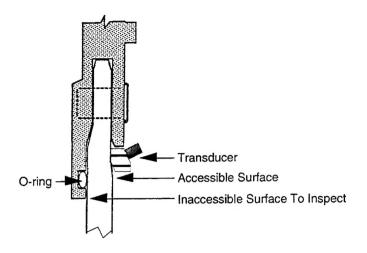
Aging concerns were raised about solid rocket motors remaining stacked for extended time periods at humid, coastal launch sites. Following a destack, corrosion was found in joint regions; see Figure 6. The concern for corrosion causing inadequate O-ring sealing resulted in the contractor implementing an ultrasonic backscatter technique to periodically inspect stacked vehicles. Unlike the previous case, the inaccessible surface to be inspected was an interior surface rather than a bondline. The geometry constraints required the design and manufacture of a custom transducer wedge by co-author M. C. Gregory.

Figure 6. Sketch of a solid rocket motor joint region. Corrosion was found on destacked hardware in the vicinity of the O-ring sealing surface.

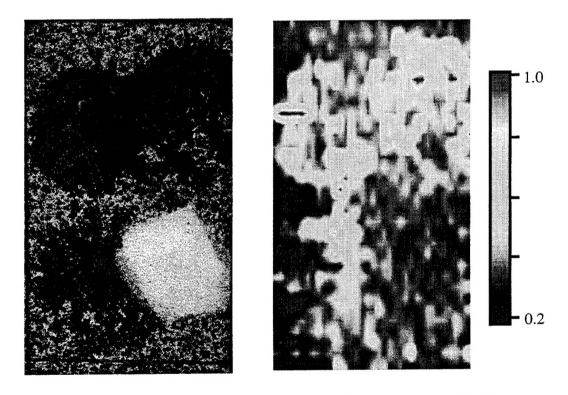
Figure 7. Comparison of visible corrosion and an ultrasonic C-scan. On the left is an optical image of a corroded D6AC steel sample, and on the right is an ultrasonic C-scan of the same sample. The C-scan data was taken with the apparatus depicted in Fig. 8. In Fig. 8, the corroded surface is opposite the surface scanned.
